Improving the Balance Sheet

Assessment Checklist

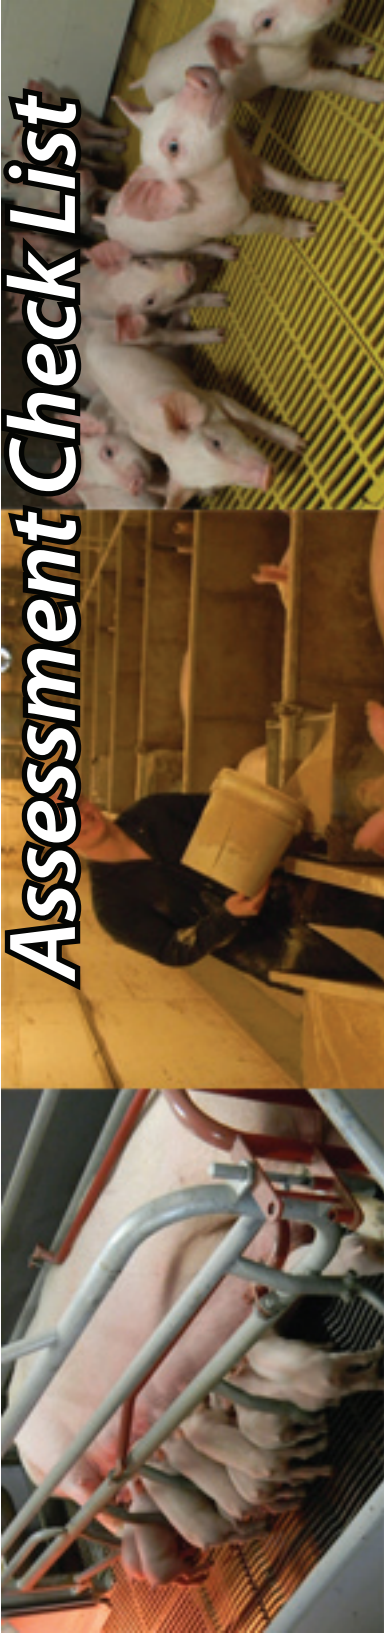
Area	Description of area observed	Risk scale 1-5	Impact of failure on farm net income 1-5	Avoidance of risk, best return score
Biosecurity				
STRUCTURAL	Cracks in foundation wall			
	Insulation, studs, vapour barrier			
	OUTSIDE			
	Pit walls			
	Eaves, soffit, fascia			
	Roof steel, seams, screws			
	Floors, cracking and heaving			
	Slats, cracks (along length or across slat)			
	Under the slat in high use areas			
	INSIDE			
Farrowing and nursery floors				
Suspended floor supports				
Ceilings plywood, PVC liners				
Interior perimeters moisture migration				
UTILITIES				
Electrical service connection to barn				
Emergency generator exhaust vent				
OUTSIDE				
Fire department access road around structure				
Water supply for fire fighting				
Exit doors and emergency egress openings clear of obstacles and functional				
Gas lines painted yellow, and other utilities clearly marked				
INSIDE				
Fire detection/alarm system (tested)

Fire extinguishers in all passageways that lead to exits (tested annually)				
OPERATIONAL				
Gravel building perimeter; control of weeds, placement of rodent control				
Sewer vent pipes clear of debris				
OUTSIDE				
Manure pump out access covers solid and secured				
Feed bins stable and secure, boot bottoms				
Feed bins stable and secure, boot bottoms				
Equipment tied to the floor				
INSIDE				
Sow stalls, feeders				
Other

The following Risk Assessment Checklist looks at four areas of consideration (Biosecurity, Structural, Utilities, Operational), certainly more could have been added but in balancing the need for brevity and ease of use against being all encompassing we opted for a quick tool that will reveal the areas of greatest need and allow you to pursue an action plan or seek professional structural or other engineering and construction advice. A special note regarding safety for people working in barns; the structural and utility sections of the checklist identify safety considerations, for example marked exits, emergency egress exits and fire separation to increase time to exit the building, these may not have been part of the original barn plan but should be considered essential upgrades as we evaluate our barn structures.
