Draeger microPac Performance for Hydrogen Sulphide Monitoring in Commercial Swine Operations

Liliane Chénard, Stéphane Lemay, and Shala Christianson 1

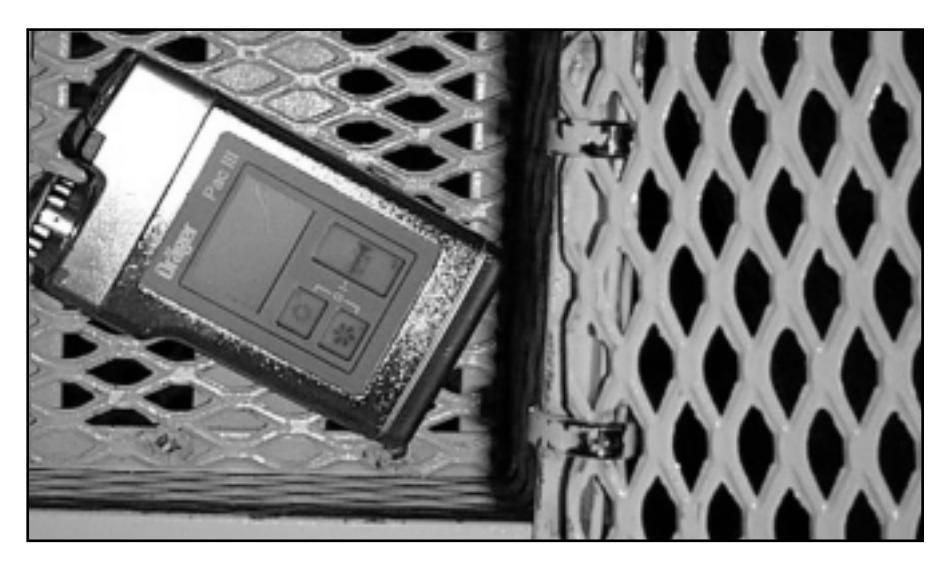
Figure 1: Draeger microPac H₂S monitor.

Until recently, systematic H₂S monitoring was not performed in the swine industry. A few incidents involving the detrimental effects of H₂S have increased the awareness of the possible hazards related to H2S and more intensive swine operators want to ensure that their workers are provided with equipment to warn them of unsafe working environments. Monitors in swine buildings are subjected to a harsh environment where dust, humidity and gases may be present and the monitors may be subject to accidental falls on the concrete or in the manure. As a result, the swine production conditions are likely to challenge the H2S monitor in a way the monitors have not previously experienced. The objective of this project was to evaluate the performance of the Draeger microPac unit (Figure 1) for H₂S monitoring in pig barns.
